## Appearance of Cracked Glass in GEOS Recycled Glass Surfaces

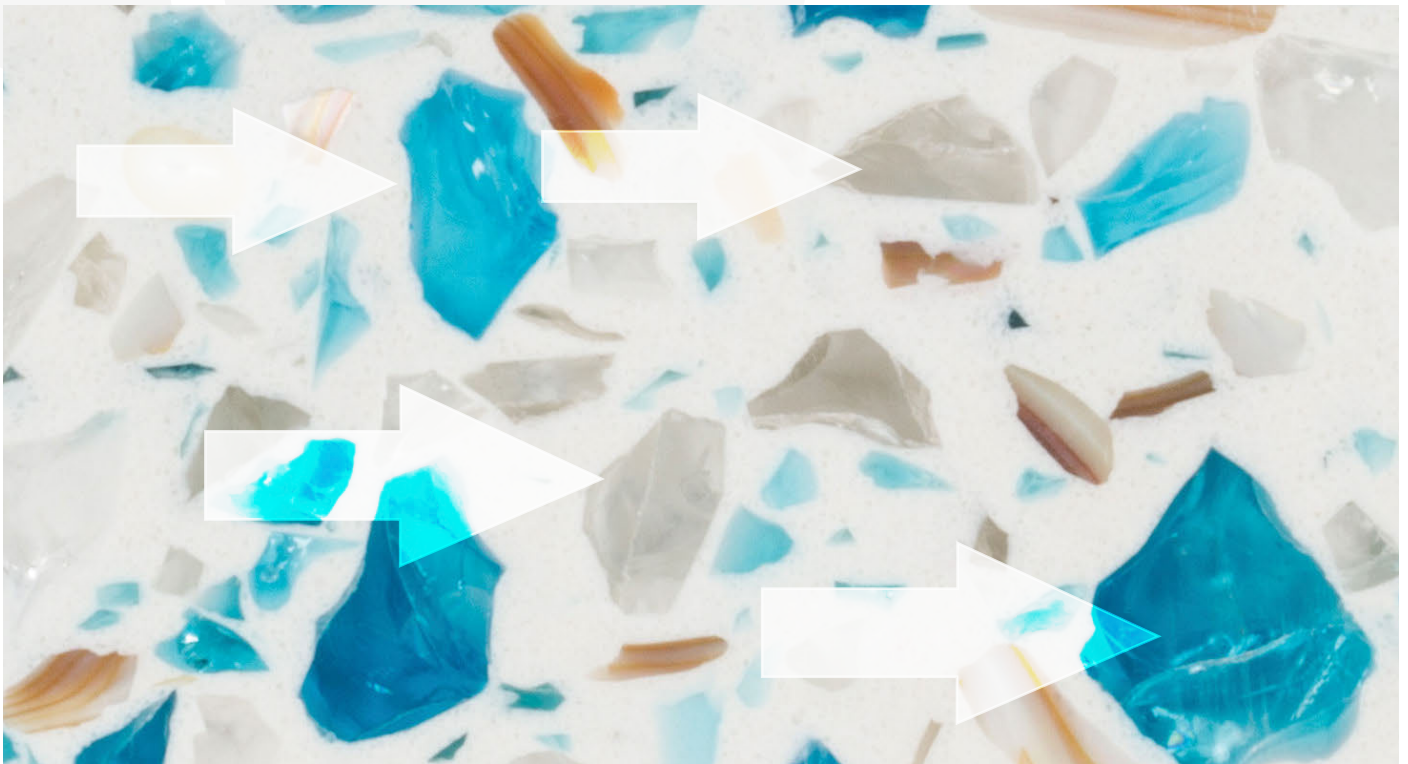
The process used to create GEOS Recycled Glass Surfaces includes a vibro-compaction process that aggressively vibrates and compacts the ingredients to give them a very tight, durable surface. During this process internal fissures can appear in the larger pieces of glass. These are superficial and do not affect the performance of the surface.

Due to the recycled glass content in GEOS Recycled Surfaces, there may be minor variations in the surface of the glass that can be felt with a bare hand. These are part of the aesthetic and are not a defect unless they are deeper than 1/16".

Example of cracked glass in surface.
